02/24/89 United Airlines

Official Accident Report Index Page

Report Number	NTSB/AAR-90/01
Access Number	PB90-910401
Report Title	Title and Subtitle Aircraft Accident Report--United Airlines Flight 811, Boeing 747-122, N4713U, Honolulu, Hawaii, February 24, 1989
Report Date	April 16, 1990
Organization Name	National Transportation Safety Board Office of Aviation Safety Washington, D.C. 20594
WUN	5059B
Sponsor Name	NATIONAL TRANSPORTATION SAFETY BOARD Washington, D.C. 20594
Report Type	Aircraft Accident Report February 24, 1989
Distribution Status	This document is available to the public through the National Technical Information Service, Springfield, Virginia 22161
Report Class	UNCLASSIFIED
Pg Class	UNCLASSIFIED
Pages	72
Abstract	<p>This report explains the sudden opening of an improperly latched cargo door in flight on United Airlines flight 811 near Honolulu, Hawaii, on February 24, 1989. The safety issues discussed in the report include the design and certification of the Boeing 747 cargo doors; the operation and maintenance of the cargo doors; portable emergency oxygen bottles; storage compartments over emergency exit doors; flight attendant communications during an emergency;

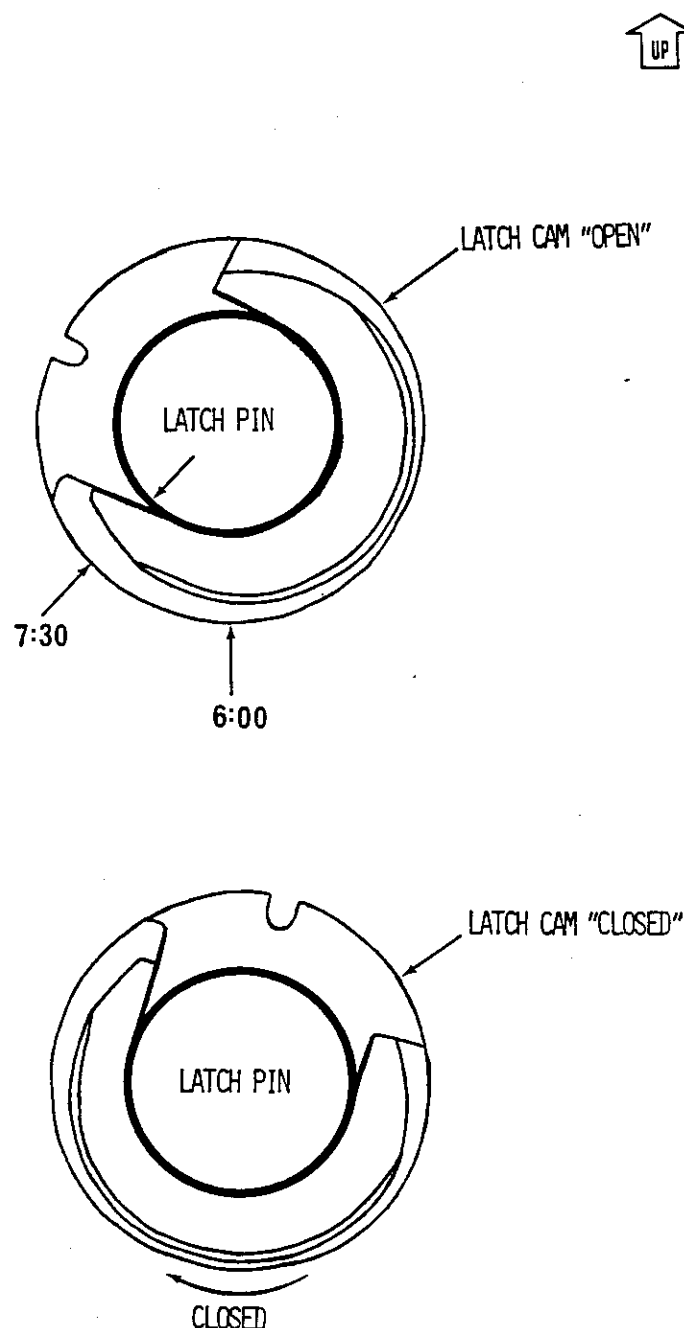
Figure 5.--Diagram of cargo door latch cam in open and closed positions.

The cargo doors on the B-747 have a master latch lock handle installed on the exterior of the door. The handle is opened and closed manually. The master latch lock handle simultaneously controls the operation of the latch lock sectors, which act as locks for the latch cams, and the two pressure relief doors located on the door. [Figure 5](#) depicts a latch pin and latch cam in an unlocked and locked condition.

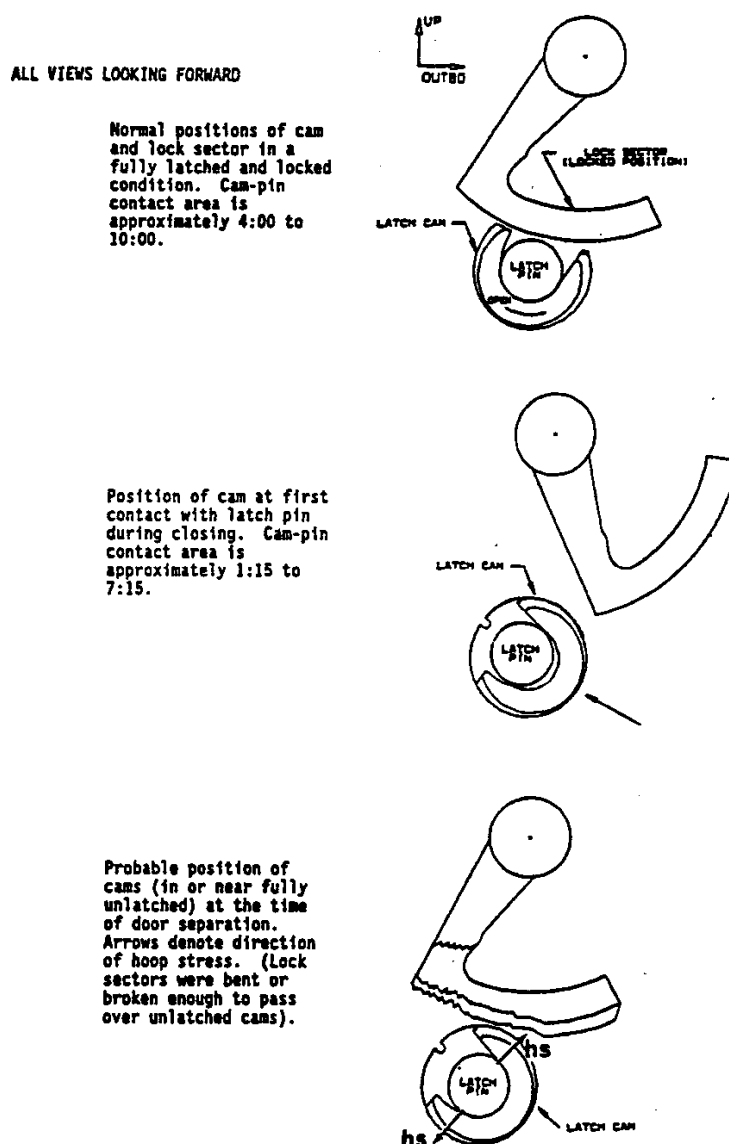
Figure 6.--Latch pin number 6.

In general, all of the forward door cargo latch pins had smooth wear over the entire portion of the pin area contacted by the cams during normal closing and opening of the door. The pins also had distinct roughened (smeared) areas between the 6:15 and the 7:30 positions([See Figure 7](#)). The roughened areas had evidence of "heat tinting" and transfer of cam material to the surface of the pins. On pins 1 and 8 the roughened areas extended past the pin bottom to the 5:00 position. The 7:30 position approximately corresponds to the area on the pin where the lower surface of the cam would be relative to the pin when the latch cams are in the unlatched or nearly unlatched position.

Note the rough and smooth areas and the steps indicating the contact area with the latch cam.

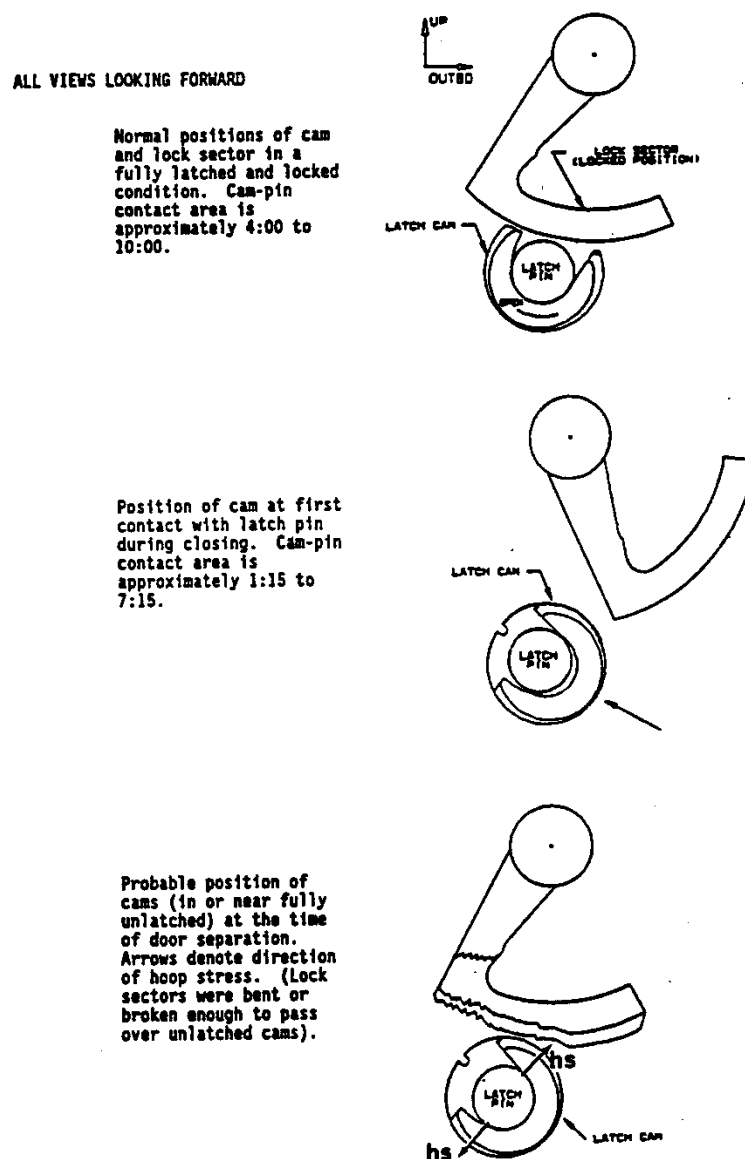
Figure 8.--Relative positions of latch cam, latch pin, and lock sector in properly latched and unlatched, and in improperly locked position.

It could not be determined whether the pressure relief door shrouds were actually installed on the forward door, although UAL records showed that they had been installed on both cargo doors of N4713U, in accordance with SB-747-52-2097. However, the shrouds were found not to be installed on the aft door, contrary to UAL records, and therefore may not have been installed on the forward door. If this were the case, the pressure relief doors could possibly have rotated shut during the pressurization cycle. However, since the closure of the pressure relief doors would back-drive the lock sectors, this scenario would presume previous damage to the sectors, which would permit the sectors to move over the unlatched cams. Although the Safety Board has concluded that the sectors had sustained previous damage, the Safety Board does not believe that the door was inadvertently left unlocked before departure.
